Case No. 2011-00176

UTILITY: Duke Energy Kentucky

LOCATION: 330 Center Street, Apartment 3A, Bellevue, Kentucky

### FIELD VISIT REPORT

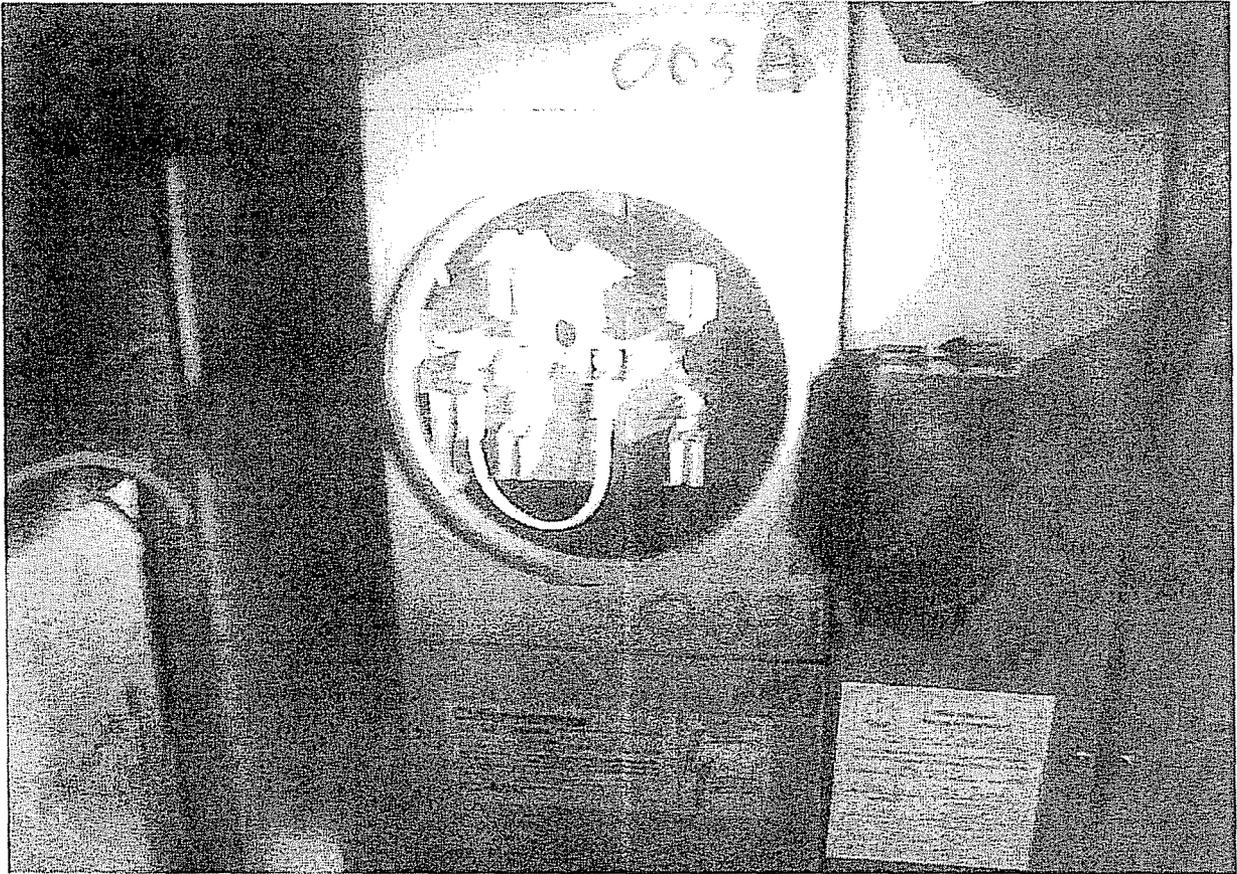
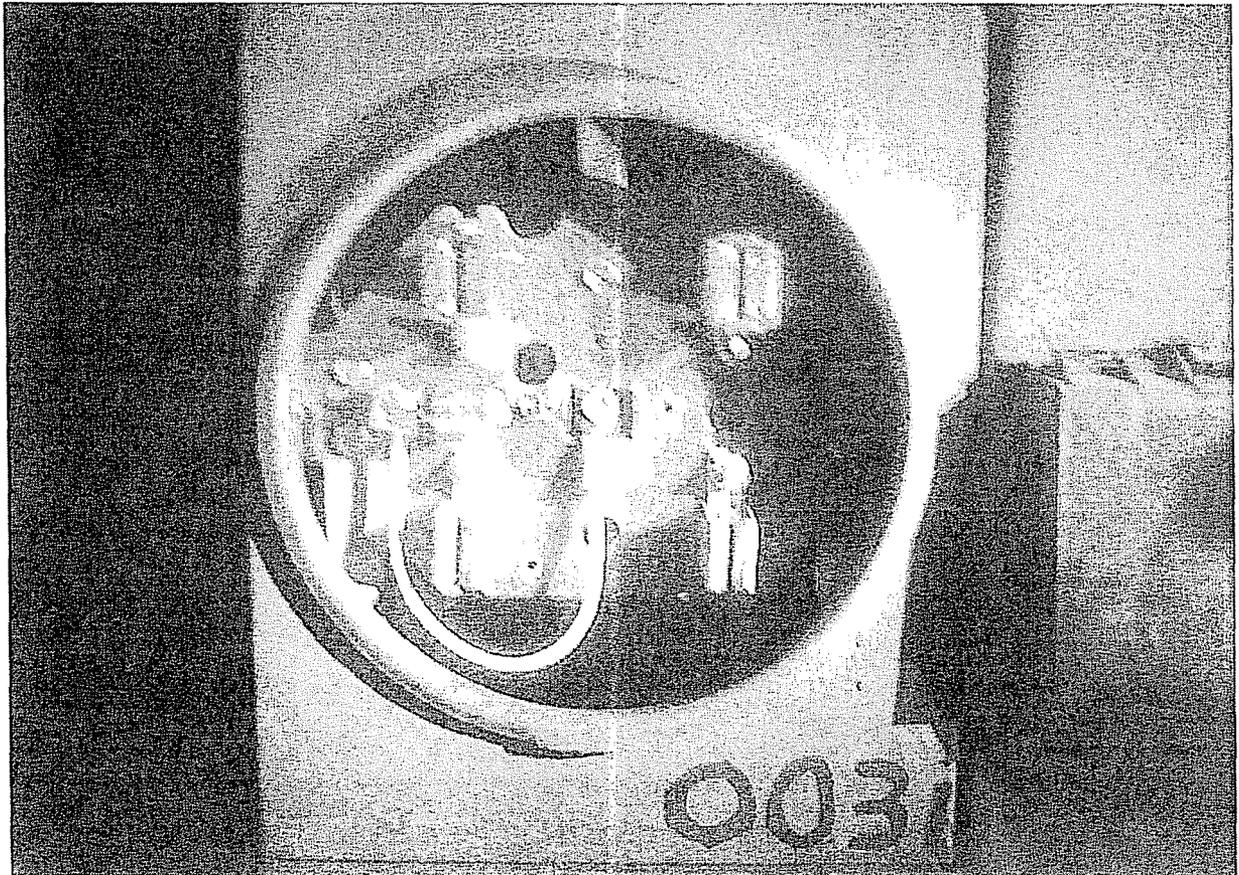
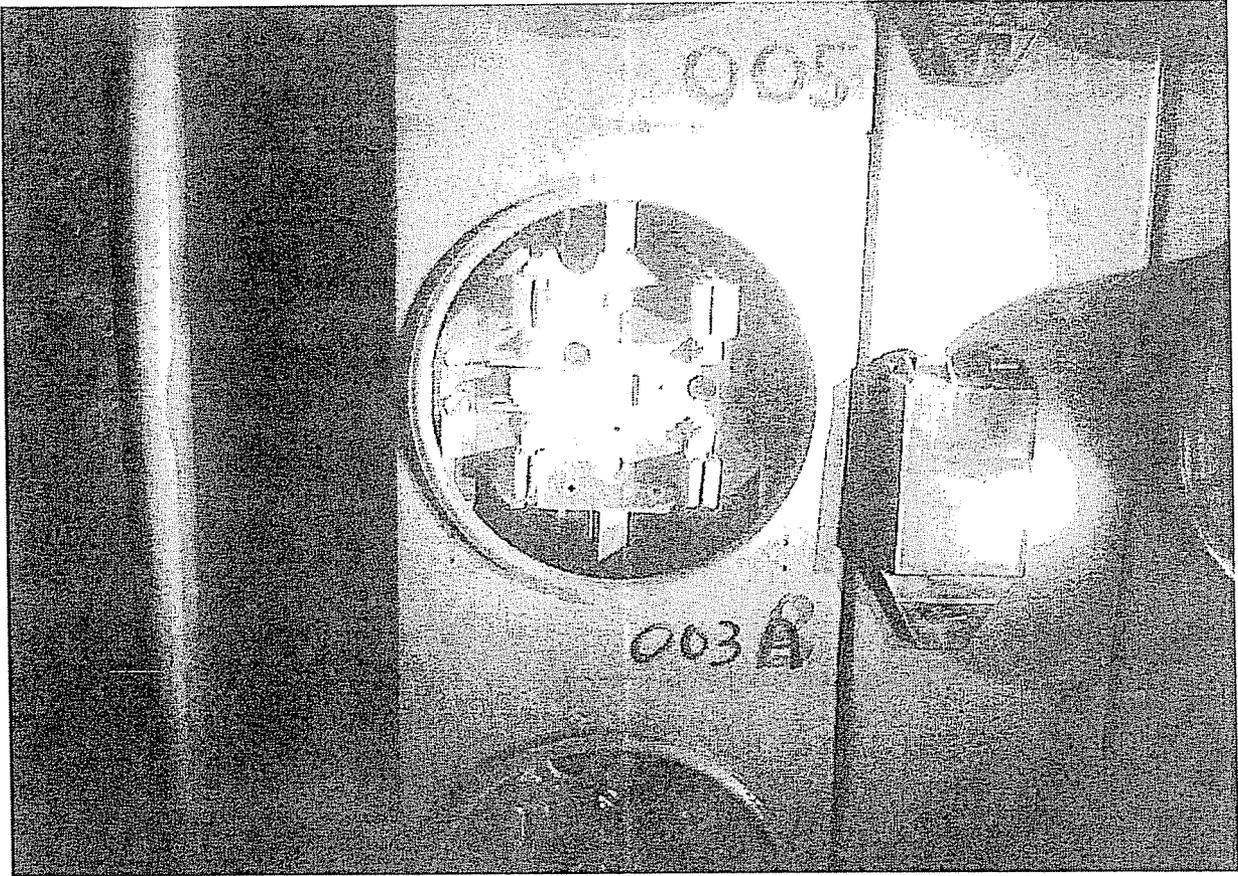
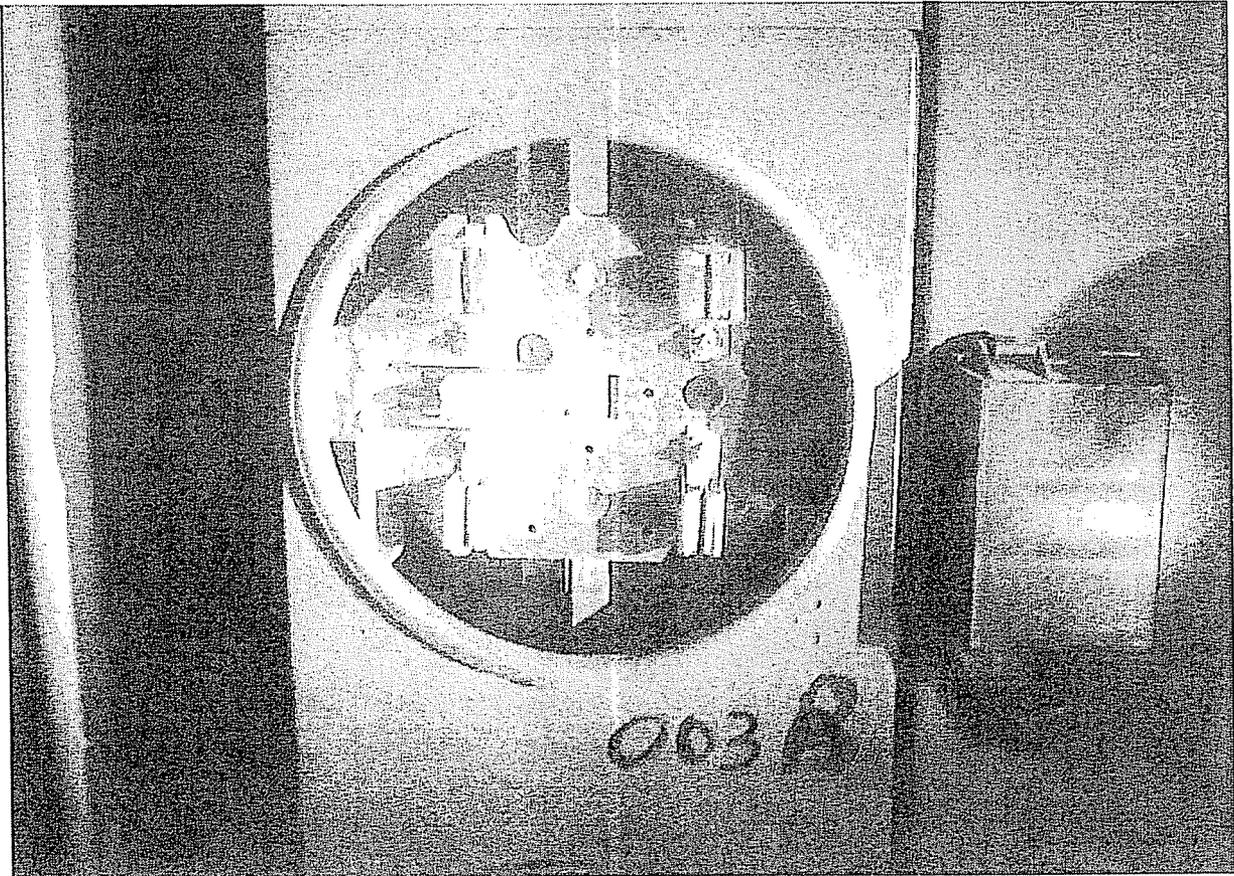
**ATTACHMENT A**  
**Photographs of Meter Base 003B**

The meter base in question (0003B) in the current dispute between Duke and Mr. Moore was visually inspected when the meter was removed by Duke's tech. The 5<sup>th</sup> lug on this meter base had burn marks on and around the 5<sup>th</sup> lug. Mr. Moore explained that he hired an electrician to install a 5<sup>th</sup> lug on this meter base during January of 2011, Mr. Moore stated the electrician caused an arc and that the electrician was shocked while making repairs to this meter base. During the visual inspection of meter base 003B, it was noted a jumper wire was installed across the 5<sup>th</sup> lug.

See Attachment A; photographs of meter base 003B. The arcing apparently damaged the 5<sup>th</sup> lug, and Duke's tech could not completely tighten the lug. Mr. Moore said the electrician installed the wire jumper before leaving. I discussed the loose 5<sup>th</sup> lugs in meter bases 003A, 006, and 004 with Mr. Moore and recommended he contact an electrician about repairing or replacing the loose 5<sup>th</sup> lugs in these meter bases. I also recommended that he check with the state electrical inspector's office to verify if the jumper in this meter base meets local and state code requirements. If repairs made to meter base 003B in January of 2011 does not meet current code requirements it will need to be corrected.

1. It was recommended that Mr. Moore verify with local and state inspectors that the repairs made to meter base 003B on January of 2011 would meet current code requirements.
2. It was recommended that Mr. Moore have a qualified electrician check meter bases 003A, 006, and 004 for loose 5<sup>th</sup> lugs as noted in this report.
3. It was recommended that if meter base 003B does not meet current code requirements, then Mr. Moore is responsible for the repairs to the meter base damaged by the electrician on January of 2011.
4. It was recommended that Duke review its policy and procedures on installing meters in a customer's meter base when a possible unsafe condition or potential code violation is noted.
